EXHIBIT 1
PHOTO REPORT – WATER LEAKAGE: “F” & 11TH STREETS INTERSECTION.

CCO Proposal - Asphalt Repairs 11th and "F" ST

PROJECT COI Storm Drain Project
Site: 11th St, Imperial CA

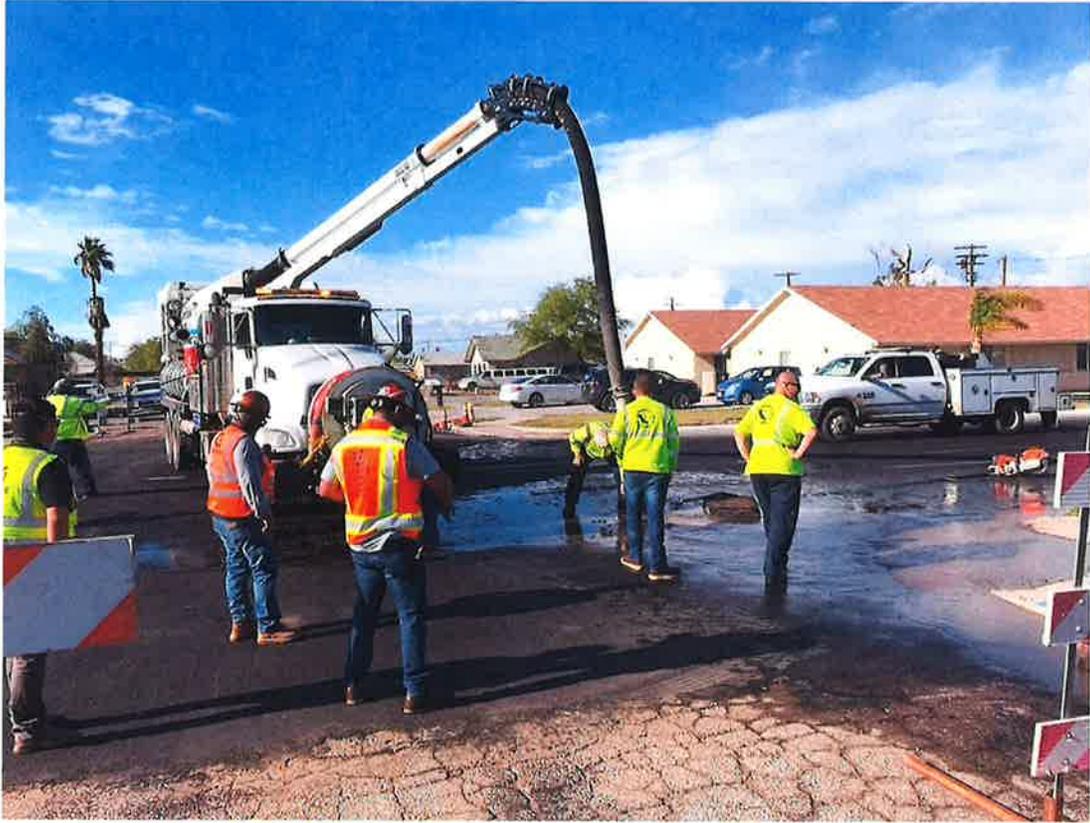
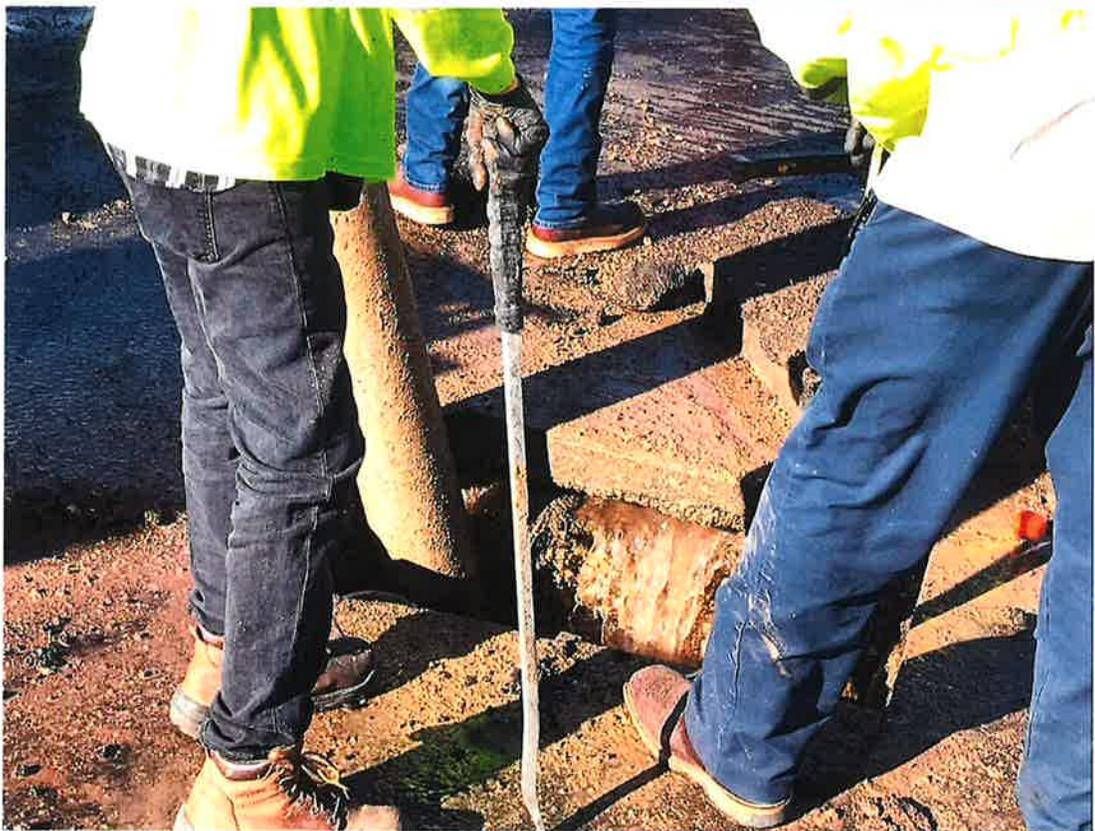
EXHIBIT 1
PHOTO REPORT – WATER LEAKAGE: “F” & 11TH STREETS INTERSECTION.

- Saw cut, remove and dispose of existing asphalt
- Remove and dispose of 9" of saturated subgrade replace with Geogrid and 9" of class II base.
- Pave 4" of 1/2" HMA PG70-10
- Complete Pavement Markings; legend and lines shall be thermoplastic as illustrated on approved improvement plans.

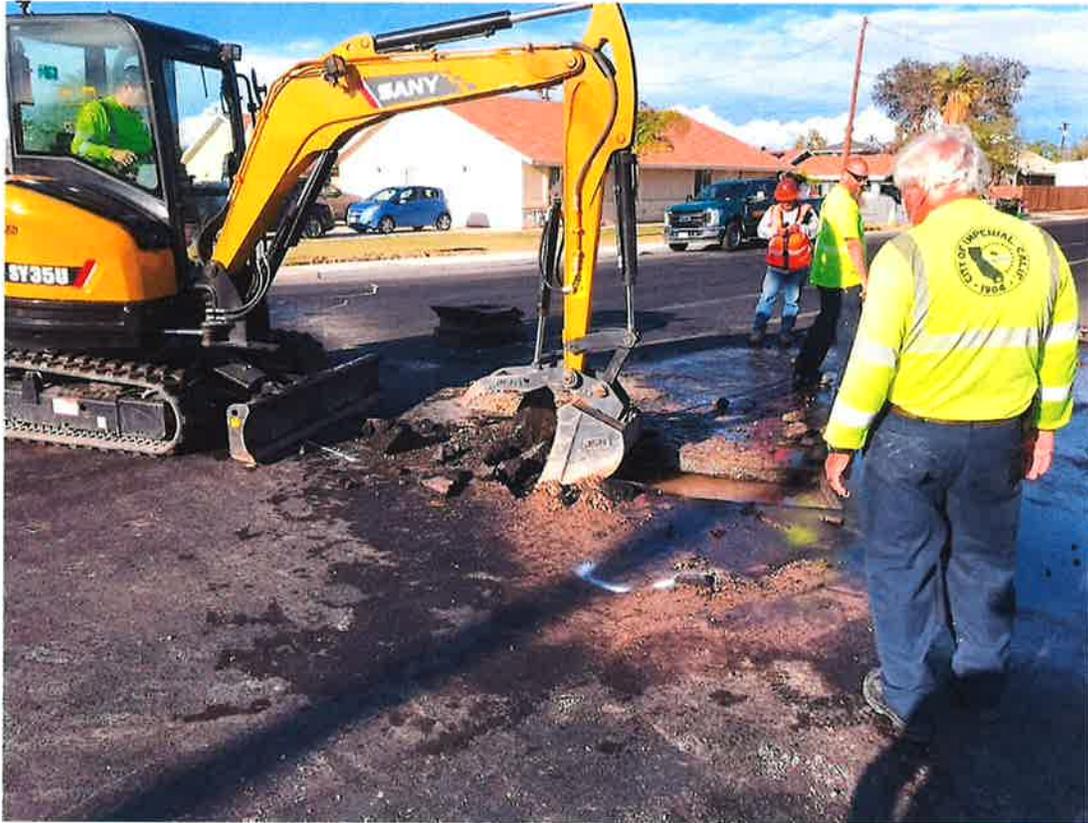
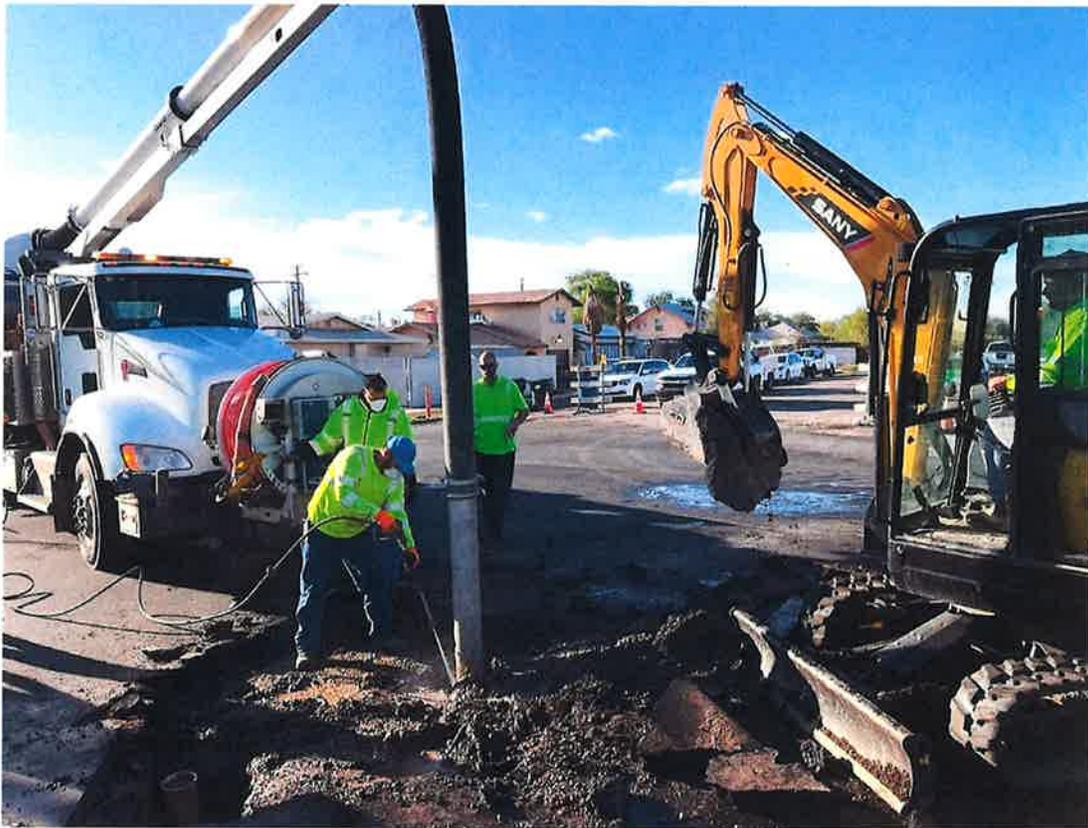
EXHIBIT 1
PHOTO REPORT – WATER LEAKAGE: “F” & 11TH STREETS INTERSECTION.

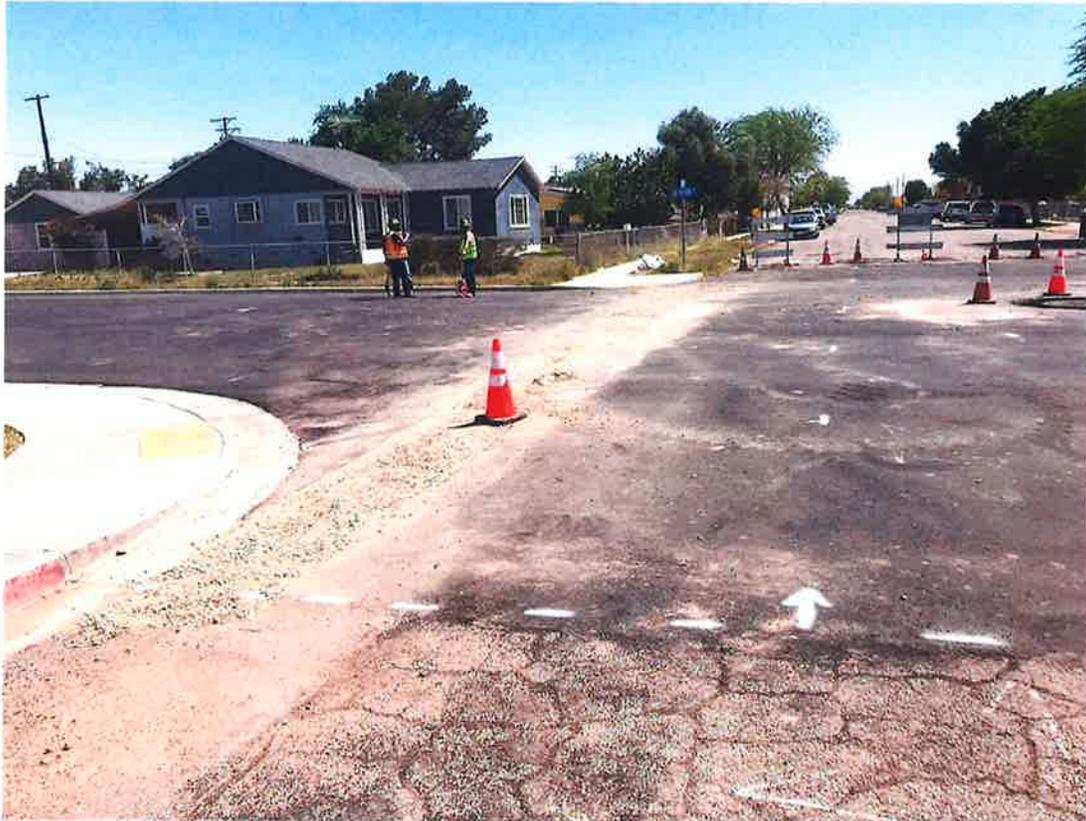
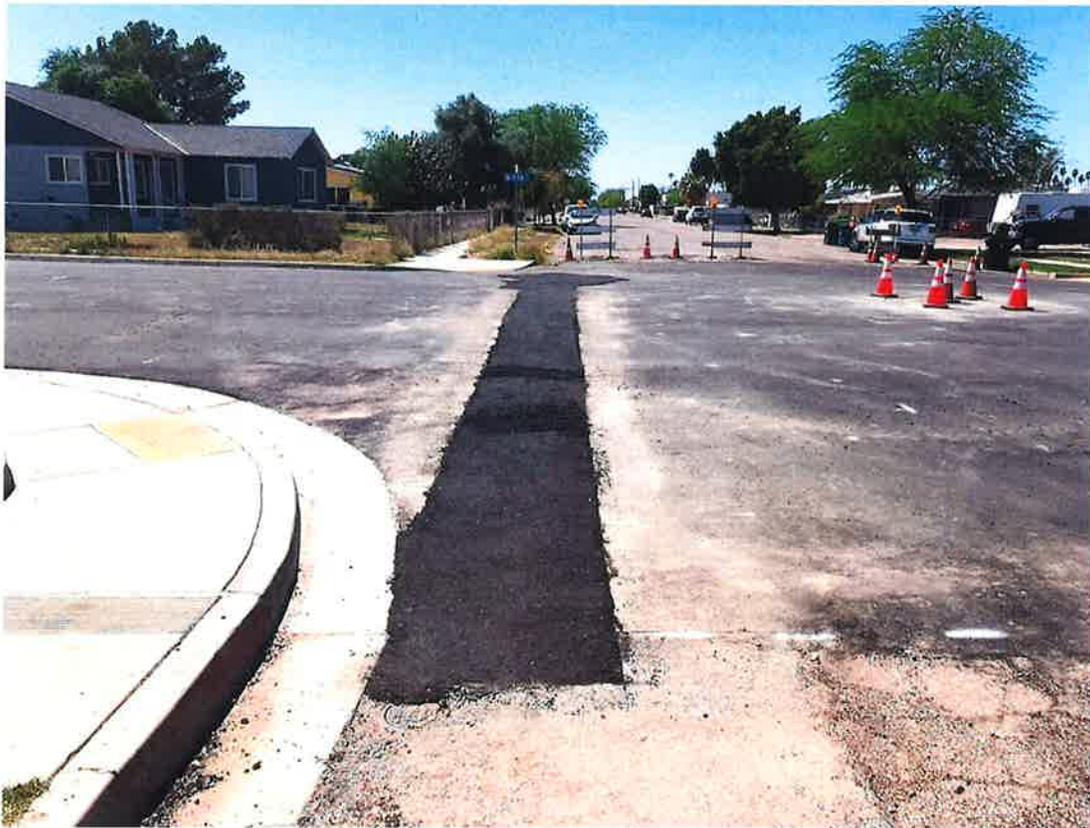
EXHIBIT 1
PHOTO REPORT – WATER LEAKAGE: “F” & 11TH STREETS INTERSECTION.
